DESIGN AND INSTALLATION
OF WALLS & CEILINGS
IN TALL BUILDINGS

INTRODUCTION

This manual is intended to provide an overview of the following:

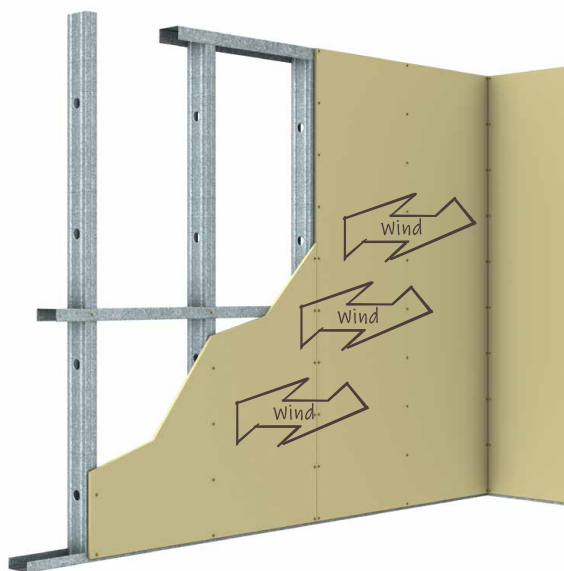
■ WIND LOAD ON WALLS

Internal pressures are determined in accordance with AS/NZS1170.2 Clause 5.3, using the basic external pressures for the building and are applicable for both walls and ceilings. The internal pressures cannot be ignored, and in some situations can be upwards of 1.0kPa.

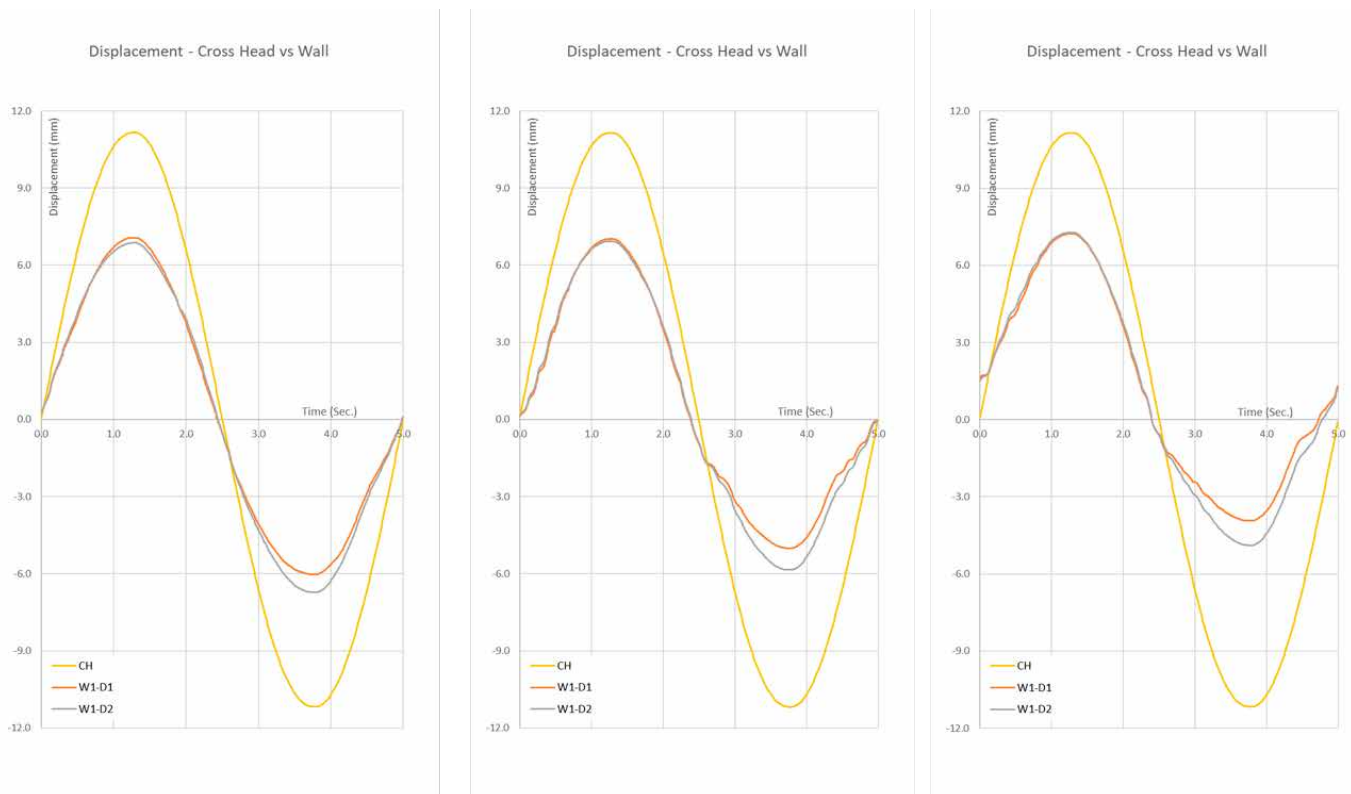
The graph on the previous page shows the comparative wall movement (orange and grey graphs) against the test rig (structure) movement (yellow graph), at an H/240 drift limit. The graphs, left to right respectively, depict (1) a conventional square set installation, (2) after removal of the screw fixing between the furring channel and perimeter channel and (3) after removal of the screw fixing between the furring channel and perimeter channel and screw fixing the perimeter channel to the plasterboard wall linings only.

It can be seen, when the test rig is moving in the positive direction, there is little change in the wall panel movement with approximately 7mm movement measured across all three wall panel tests. This is because the plasterboard ceiling is bearing against the end wall panel and pushing the wall panel, in addition to the racking force generated along the ceiling edge due to the perimeter channel and ceiling lining fixings into the wall panel.

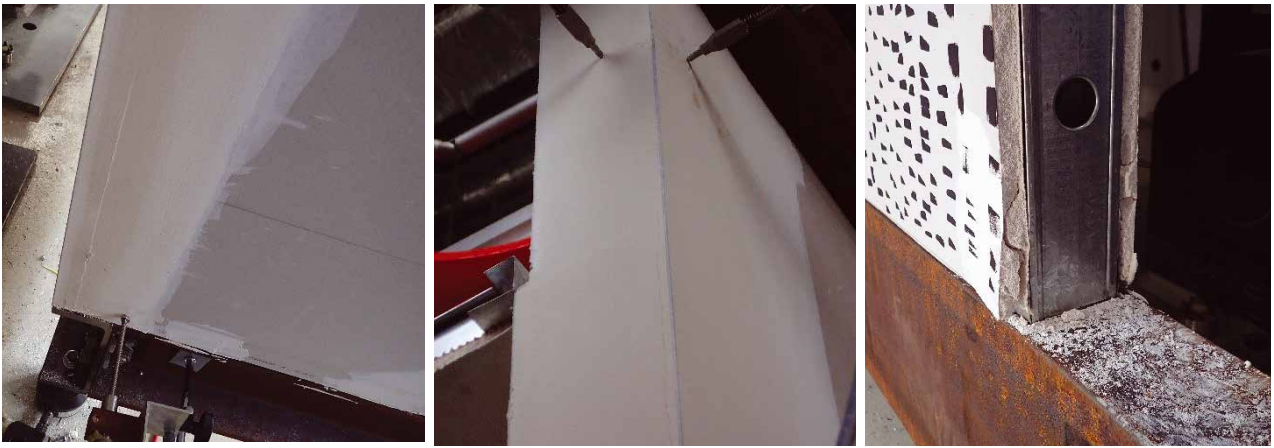
■ PHOTOS 3,4 & 5 – R2 L/360 ($\pm 5.40\text{MM}$) EXTERNAL CORNER, NIB WALL END, DOOR OPENING BASE DAMAGE

There was visible damage to the wall systems after the completion of the four (4) L/360 drift tests, comprising X and Y directions in isolation and $X \pm Y$ in a clover leaf pattern. The no damage limit appears to lie somewhere between L/500 and L/360 drift for this type of construction.

Considering the New Zealand serviceability limits it appears SLS1 would be satisfied with an L/500 drift limit, and the next consideration would be the operational functionality limit (SLS2).

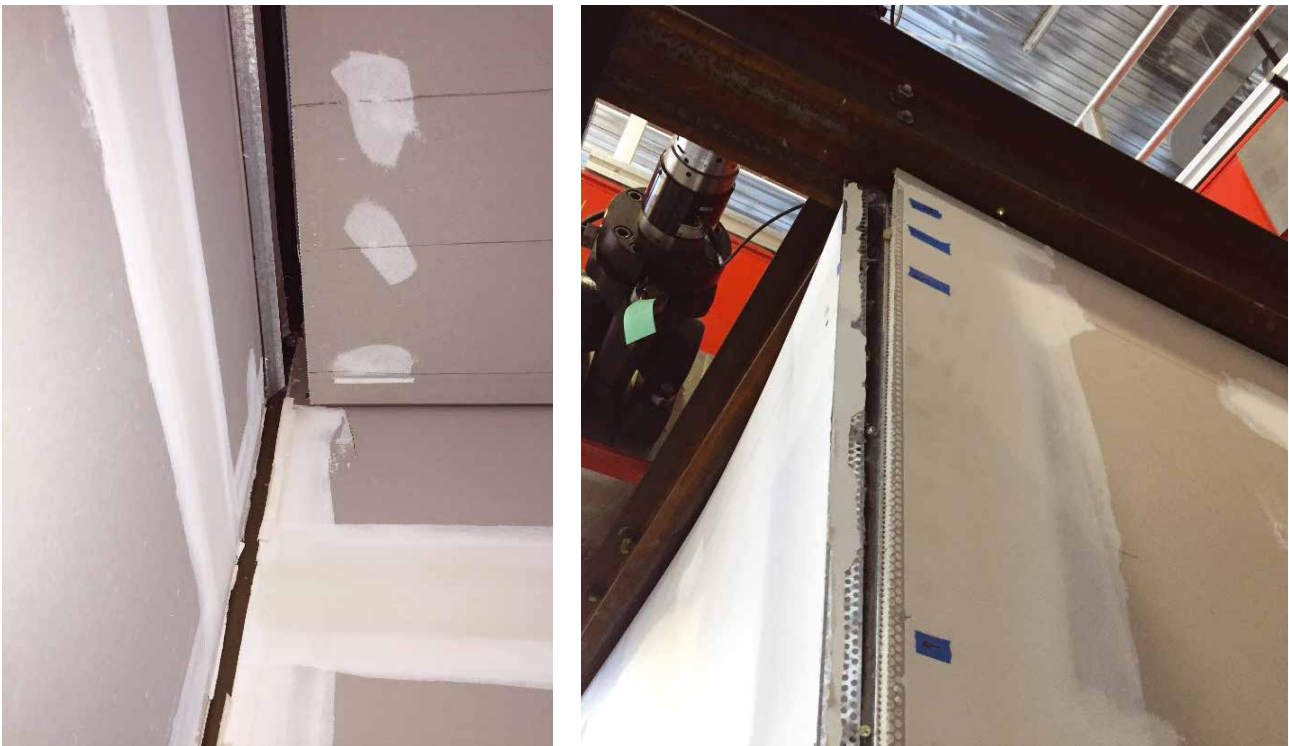
■ PHOTOS 6 & 7 – 1.5% DRIFT (40.5MM) INTERNAL CORNER, CEILING JUNCTION AND EXTERNAL CORNER

Between the L/360 (5.40mm) and 1.5% drift limits the damage to the wall and ceiling systems propagates and photos 6 and 7 show the extent of damage at the 1.5% drift limit. This level of damage and separation, whilst not resulting in loss of stability, would be quite disconcerting to any occupant of the building and would present significant issues for maintaining operational functionality for any services crossing these building elements.

Considering the New Zealand serviceability limits it appears SLS2 could be satisfied at approximately L/240 drift limits, noting that patch and paint repairs would be necessary however the expected damage would not require immediate repair and these could be scheduled with other works as appropriate.

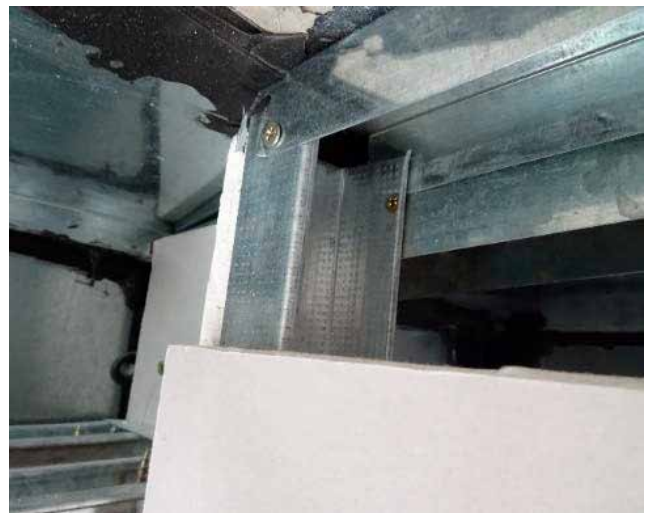
1. Screw fixings installed into head track in some locations
2. Inadequate clearances between wall studs and services
3. Walls lined one side were not screw fixed into base track on the unlined side of wall
4. Nogging installation method not per Rondo recommendation
5. Temporary location screws in head track weren't removed prior to linings being installed
6. Header Track upturn too long and metal to metal contact with head track
7. Conventional Head Track (28mm flange) used in lieu of Deflection Head Track at column location
8. Insufficient stud engagement in Head Track
9. Wall studs cut without strengthening at cut location
10. Screw fixing into the bathroom jamb stud was removed and the stud moved such that the screw hole was no longer aligned, indicating the stud was under significant stress as a result
11. Linings screw fixed through glue daub locations

■ STEEL STUD FIXED INTO HEAD TRACK

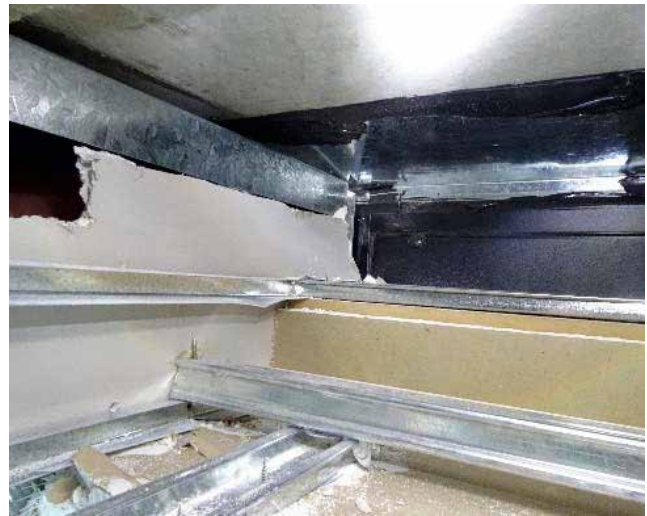
12. Top Cross Rail screw fixed to perimeter channel
13. Inadequate clearances provided to services
14. Top Cross Rail and Furring Channels installed with inadequate clearances to abutting walls
15. Furring Channel Interchange Clips legs bent outwards at some locations
16. Suspension rods installed with large radius bends
17. Ceiling Suspension Hangers installed using power actuated fasteners, with concrete bursting evident at many fixing locations
18. Screws fixed through Furring Channel at suspension clip locations

■ TCR SCREW FIXED TO PERIMETER CHANNEL AND CONTACT WITH LINING

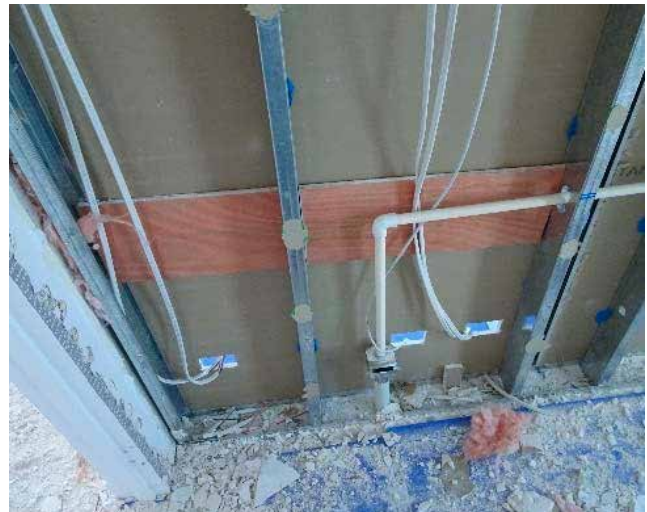
19. Services installed with inadequate clearances to stud framing
20. Services installed with inadequate clearances to ceiling framing members
21. Installed services had insufficient space within the ceiling plenum in the bathroom and were bearing against the hallway wall
22. Drainage conduit for AC unit was installed without grommets or provision to separate the pipe from the wall stud and was rubbing on the cut service hole edge
23. Head Tracks cut unnecessarily for electrical cables. Where the internal non-rated wall linings are terminated below the head tracks the electrical services can be passed down the wall cavity without needing to cut the head tracks
24. Services penetrations through acoustic wall not provided with acoustic treatment

■ MISSING GROMMET AND PIPE SCRAPING ON STUD WEB CAUSING NOISE
